RDA Report

*Browns Farm Homeowners Association
Account 3007 - October 15, 2024*

CFS RESERVE ANALYSIS REPORT SUMMARY

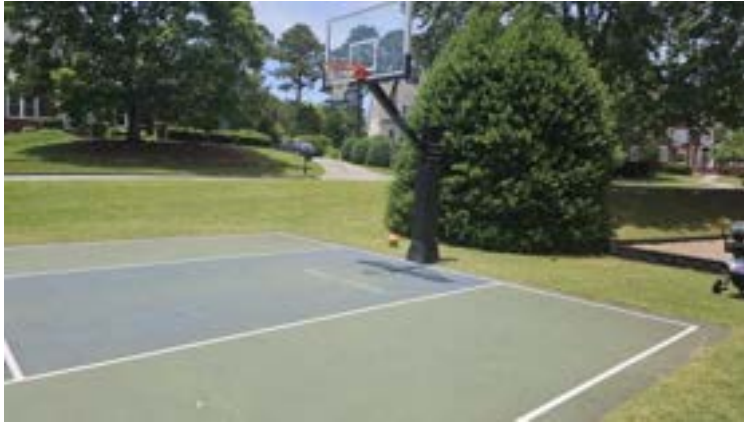
80.jpg

Created: Fri 31 May 13:56 2024
Group: Sports Area
Basketball Court
Surface 30' x 40'
Backboard Mega Slam.
Pour condition
