Brown's Farm HOA Reserve Study - Draft Report as of January 1, 2018

Regarding: January 1, 2018 - Level I Reserve Study

Brown's Farm HOA
Inspected: July 30, 2017

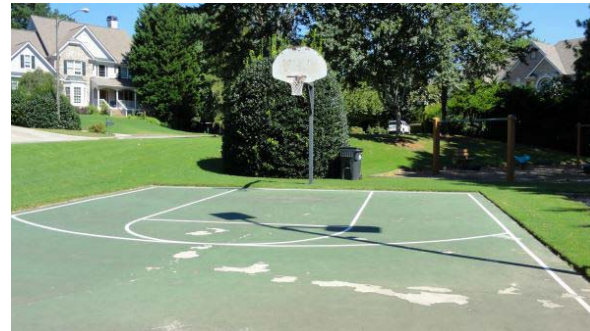
Basketball Court: Seal & Stripe (1/2)

Item Number	61
Type	Common Area
Category	Basketball
Measurement Basis	EA
Estimated Useful Life	5 Years
Basis Cost	\$ 1,900.00
Tracking	Logistical
Method	Fixed

Location	Desc.	Condition	Service Date	Replace Date	Rem Life	Adj Life	Quantity	Current Cost	Future Cost
Basketball Court			04/01/2013	04/01/2018	0:03	5:00	1	1,900.00	1,911.90
								\$ 1,900.00	\$ 1,911.90

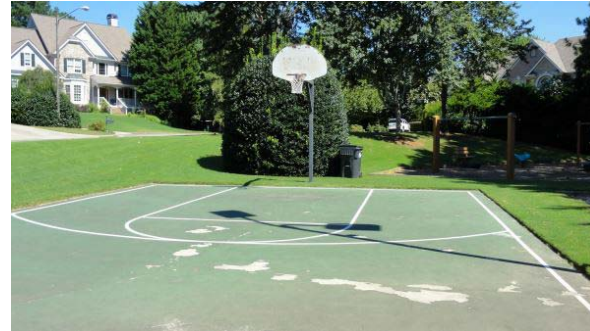
Basketball Goals R&R

The budget would typically assume replacing the entire goal assembly to comply with safety regulations. However given the good condition of the pole, the pole needs to be padded and the backboard replaced immediately

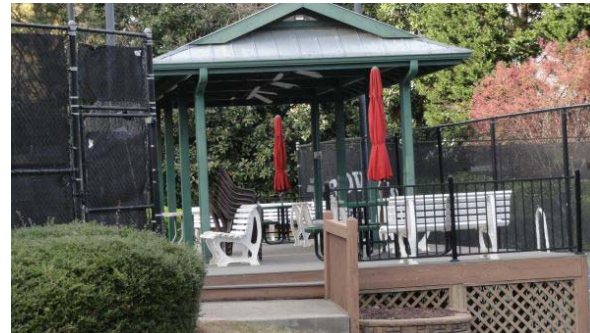
Deck: Composite Deck R&R

For the life expectancy to be maximized, all penetrations must be filled and maintained. The product is a composite material containing wood and therefore can mildew on the inside of the planks with moisture penetration.

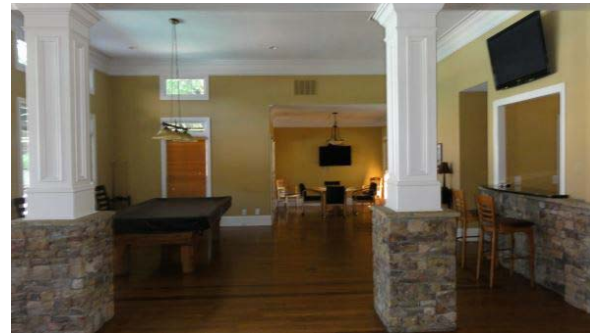
Furniture, Fixtures & Decor Items R&R

Item Number	11
Type	Common Area
Category	Furniture & Fixtures
Measurement Basis	LS
Estimated Useful Life	20 Years
Basis Cost	\$ 1.00
Tracking	Logistical
Method	Fixed

Location	Desc.	Condition	Service Date	Replace Date	Rem Life	Adj Life	Quantity	Current Cost	Future Cost
Clubhouse			04/01/2012	04/01/2032	14:03	20:00	20,000	20,000.00	20,000.00
								\$ 20,000.00	\$ 20,000.00

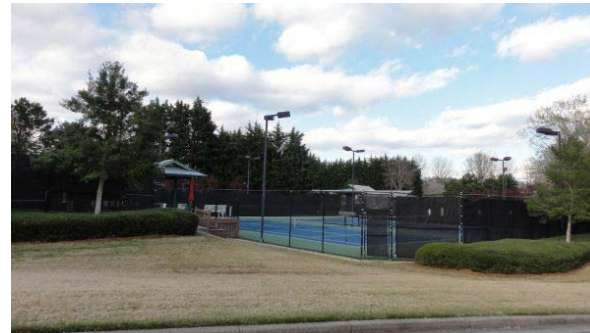
Paint: Tennis Court Light Assemblies

Item Number	28
Type	Common Area
Category	Paint
Measurement Basis	EA
Estimated Useful Life	25 Years
Basis Cost	\$ 150.00
Tracking	Logistical
Method	Fixed

Location	Desc.	Condition	Service Date	Replace Date	Rem Life	Adj Life	Quantity	Current Cost	Future Cost
Tennis Courts			04/01/1995	04/01/2020	2:03	25:00	14	2,100.00	2,221.38
								\$ 2,100.00	\$ 2,221.38

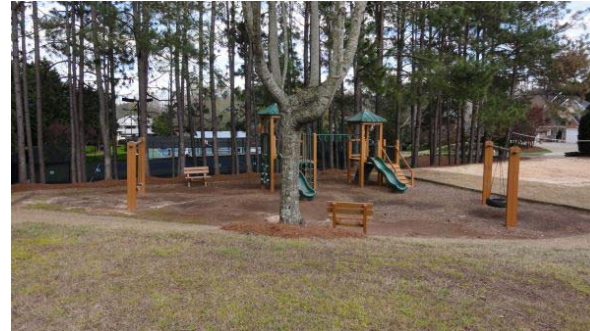
Playground (Basic) Replacement

Item Number	34
Type	Common Area
Category	Playground
Measurement Basis	EA
Estimated Useful Life	30 Years
Basis Cost	\$ 10,000.00
Tracking	Logistical
Method	Fixed

Location	Desc.	Condition	Service Date	Replace Date	Rem Life	Adj Life	Quantity	Current Cost	Future Cost
Playground			04/01/1995	04/01/2025	7:03	30:00	1	10,000.00	11,984.89
								\$ 10,000.00	\$ 11,984.89

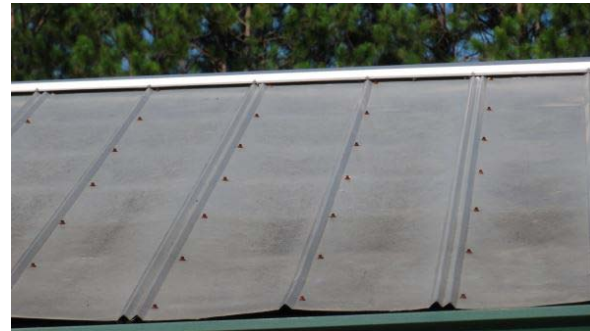
Roof: Metal Standing Seam R&R

The roof of the clubhouse is in good condition. When replaced, there will be a waste factor of 15% to 20% because of the design.

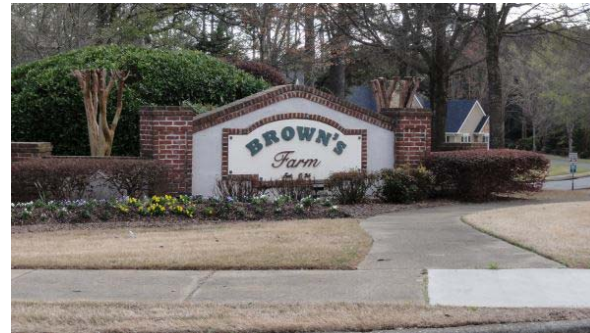
Sign (Entrance) : Refresh/Repaint

Item Number	47
Type	Common Area
Category	Signage
Measurement Basis	EA
Estimated Useful Life	8 Years
Basis Cost	\$ 400.00
Tracking	Logistical
Method	Fixed

Location	Desc.	Condition	Service Date	Replace Date	Rem Life	Adj Life	Quantity	Current Cost	Future Cost
Community At Lar			04/01/2015	04/01/2023	5:03	8:00	3	1,200.00	1,368.12
								\$ 1,200.00	\$ 1,368.12

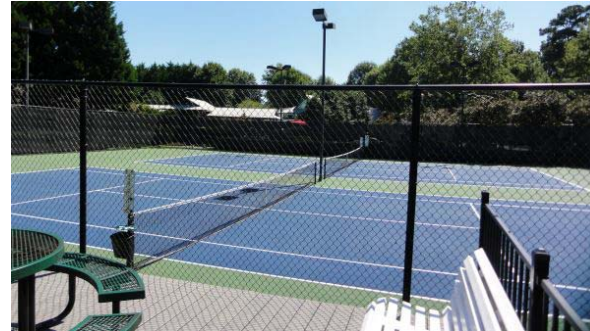
Tennis Court: Recoat

Item Number	48
Type	Common Area
Category	Tennis
Measurement Basis	EA
Estimated Useful Life	6 Years
Basis Cost	\$ 2,600.00
Tracking	Logistical
Method	One Time

Location	Desc.	Condition	Service Date	Replace Date	Rem Life	Adj Life	Quantity	Current Cost	Future Cost
Tennis Courts				04/01/2018	0:03	6:00	4	10,400.00	10,465.14
Tennis Courts				04/01/2024	6:03	6:03	4	10,400.00	12,156.86
Tennis Courts				04/01/2030	12:03	12:03	4	10,400.00	14,122.05
								<u>\$ 31,200.00</u>	<u>\$ 36,744.05</u>

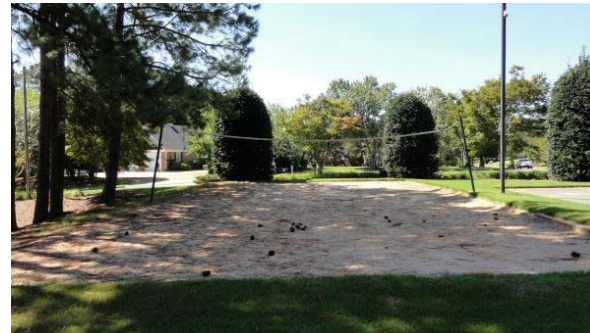
Volley Ball Court: Add 6" Sand

Item Number	53
Type	Common Area
Category	Amenities
Measurement Basis	CY
Estimated Useful Life	5 Years
Basis Cost	\$ 35.00
Tracking	Logistical
Method	Fixed

Location	Desc.	Condition	Service Date	Replace Date	Rem Life	Adj Life	Quantity	Current Cost	Future Cost
VolleyBall Court			04/01/2013	04/01/2018	0:03	5:00	35	1,225.00	1,232.67
								\$ 1,225.00	\$ 1,232.67

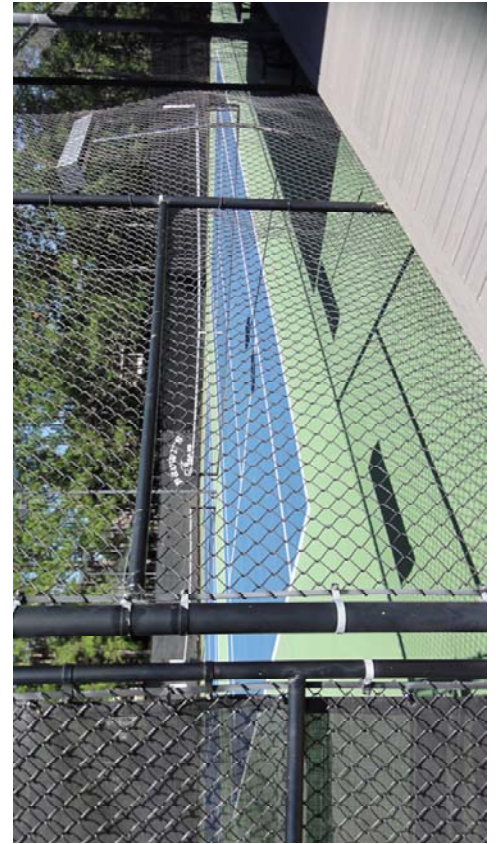
2017 #9

Photo #9 – Repair fencing

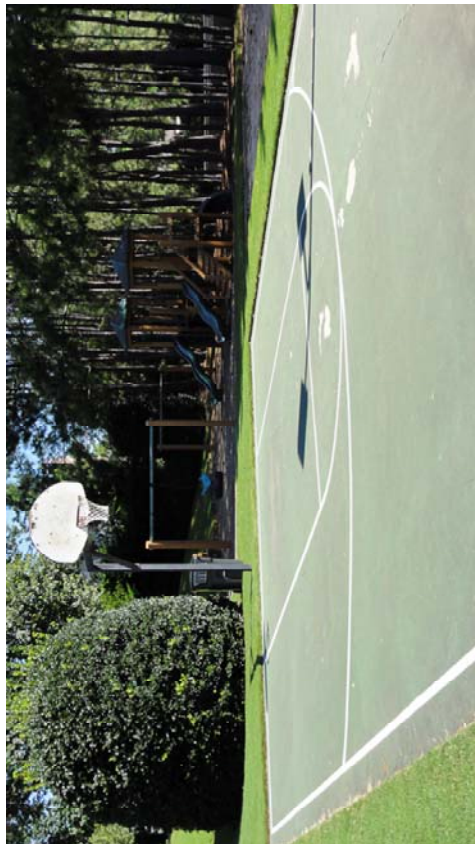
2017 #11

Photo #11 – Install pad on goal post

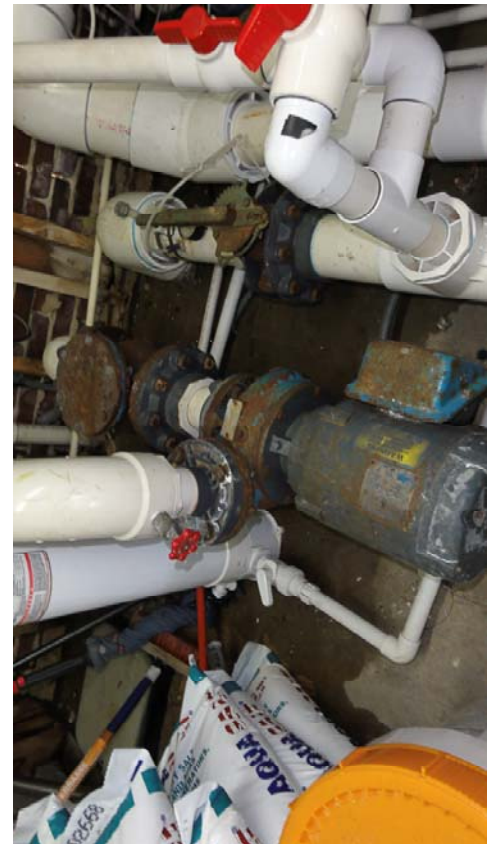
2017 #12

Photo #12 – Repair leaks in pumphoom, install code complaint ventilation fans per code, insulate and cover walls with code compliant covering.
