RDA Report

*Browns Farm Homeowners Association
Account 3007 - October 15, 2024*

CFS RESERVE ANALYSIS REPORT SUMMARY

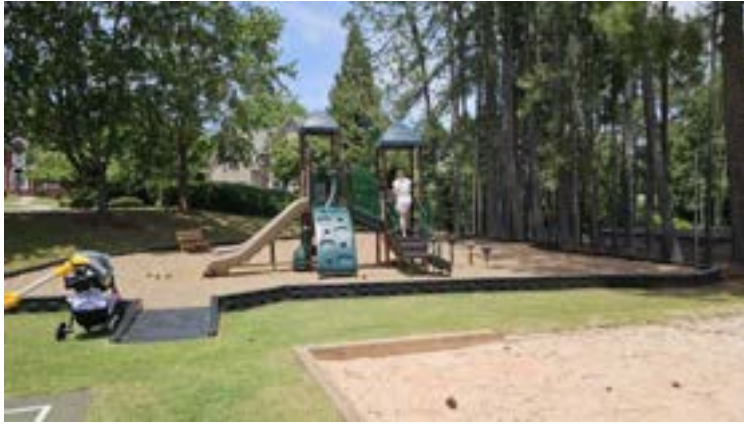
82.jpg

Created: Fri 31 May 14:01 2024
Group: Sports Area
Tot Lot
Swing Set 4 Swing
6 Station Play Ground Equipment
Boarder 192' lin
1 vapor light

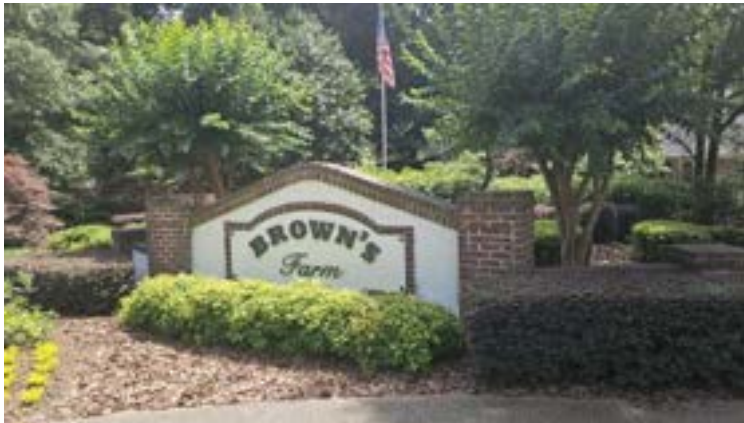
92.jpg

Created: Fri 31 May 14:37 2024
Monument Sign
